# VETERAN'S MEMORIAL PARK NORTH END SHORE PROTECTION STUDY FOR THE CITY OF BAY CITY

EDMANDS ENGINEERING, INC.

AUGUST, 1982

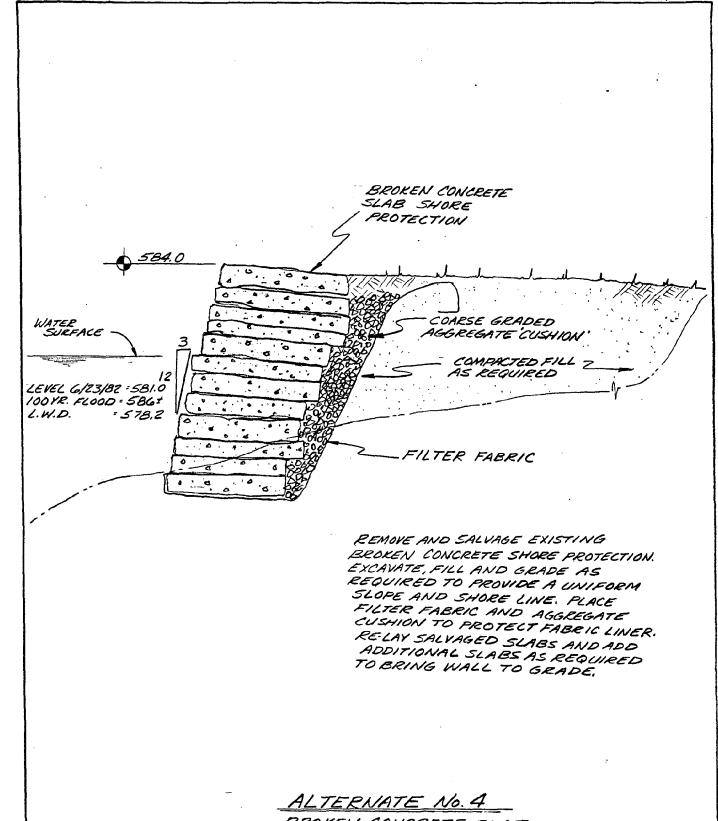
BROKEN CONCRETE SLAB SHORE PROTECTION

This alternative would reuse the existing concrete slabs and would require that they be removed, a bedding be prepared, along with a fabric filter and the slabs repiled. Additional broken concrete would have to be provided to raise the top elevation above the current elevations.

This option, though the least costly, will provide a harbor for rats, muskrats and other animals. Access will be limited due to the vertical face of the concrete. Vandalism is not expected to be a problem because of the weight of the slabs. Reflective wave action would be minimized.

4.	Broken Concrete Slab Shore Protection Remove and salvage existing concrete shore protection. Excavate, backfill, grade as required, place geotextile filter fabric material, and place coarse graded aggregate cushion. Replace salvaged concrete slabs and add additional slabs as required to bring wall to grade. Additional broken concrete to be furnished by the City and placed by the Contractor.	\$150/L.F.
